**Docket No. 217 – Development and Management Plan Inspection**

Northeast Utilities Service Company Certificate of Environmental Compatibility and Public Need for the construction of a 345-kV electric transmission line and reconstruction of an existing 115-kV electric transmission line between Connecticut Light and Power Company's Plumtree Substation in Bethel, through the towns of Redding, Weston, and Wilton, and to the Norwalk Substation in Norwalk, Connecticut.

**Date:** June 10, 2004

**Location:** Norwalk Substation Expansion

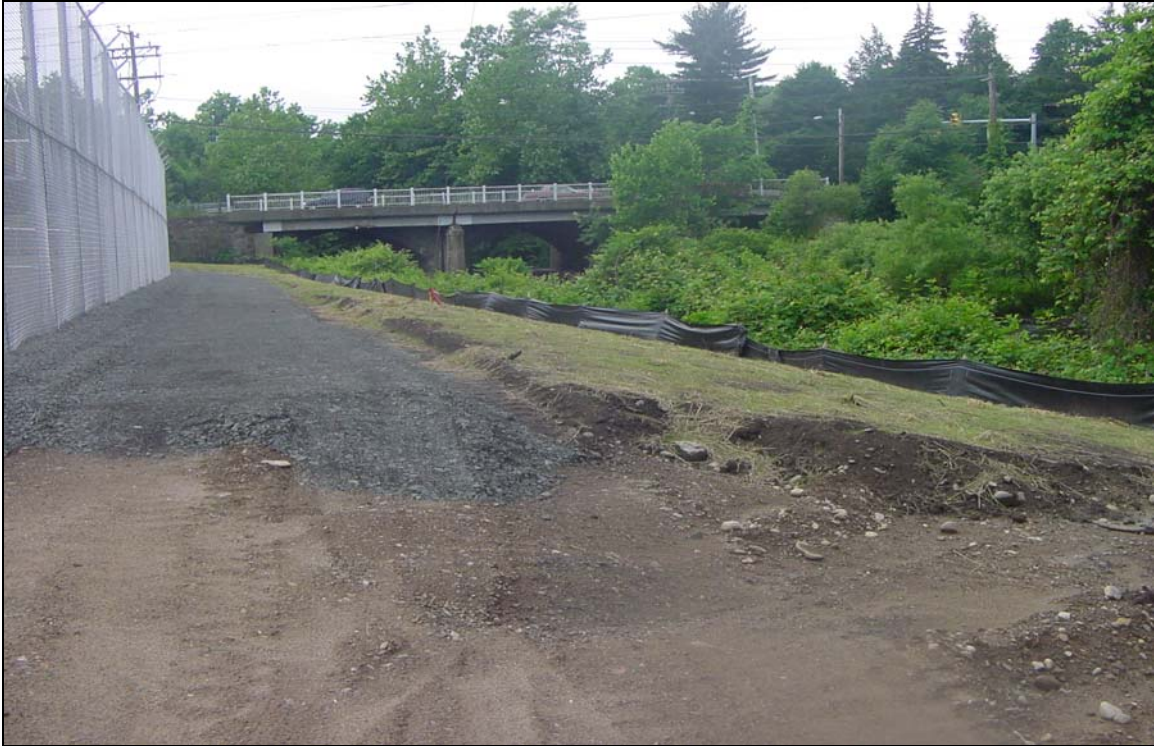
THE AREA ADJACENT TO THE SOUTHERN PORTION OF THE BIKE PATH IS EXPERIENCING GOOD VEGETATIVE GROWTH. 6/10/04

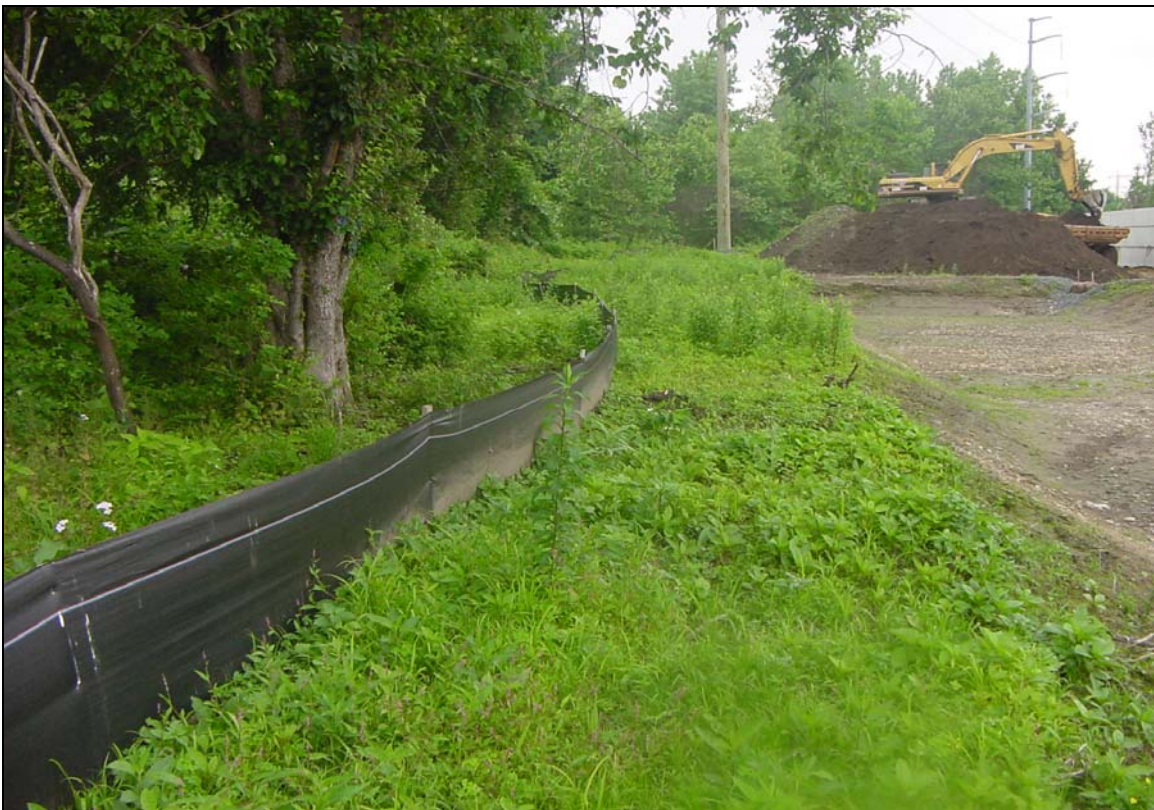
VIEW ALONG THE SILT FENCE ADJACENT TO THE RIVER. VEGETATIVE GROWTH IS COMING IN VERY WELL AND THE TOPSOIL STOCKPILE (BACKGROUND) IS BEING UTILIZED ON SITE. 6/10/04

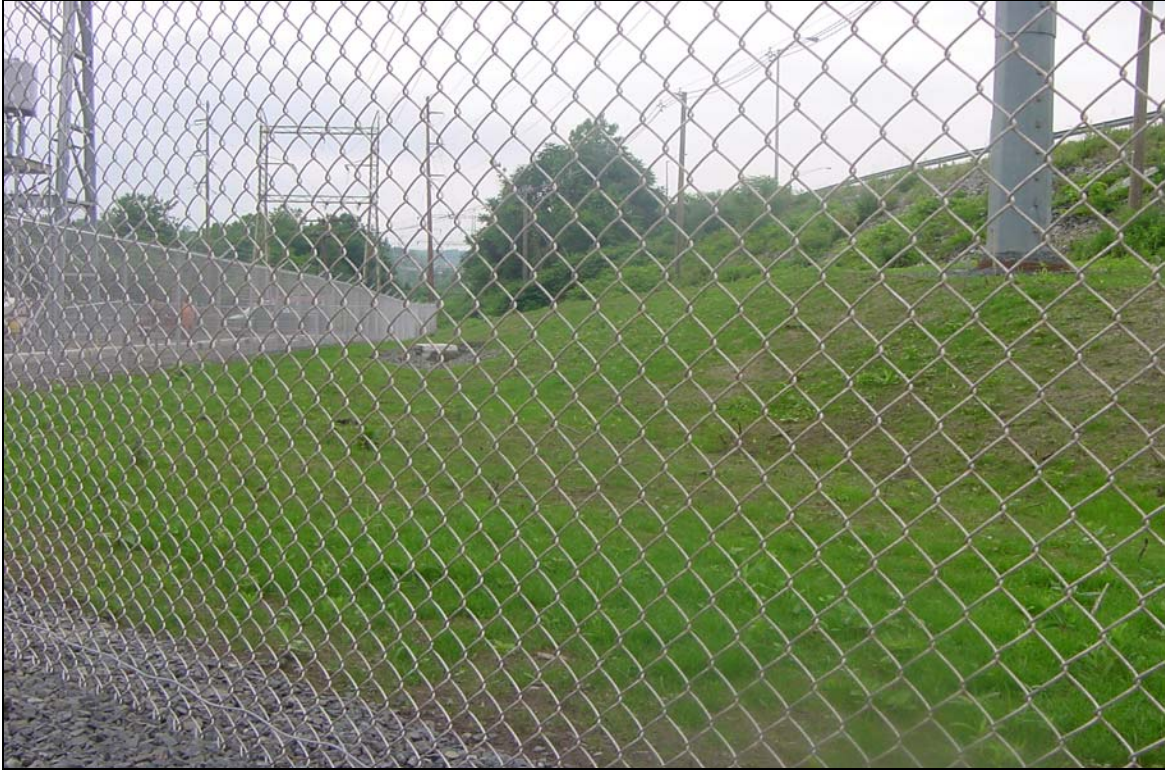
Erosion and Sediment Controls (includes inspection within 24 hours of a storm event)	<ul style="list-style-type: none"> <li>- Repairs have been made to the silt fence and it is in good shape. 6/10/04</li> <li>- The hydroseeded area below the Route 7 ramp and above wall #4 is starting to vegetate but is still fairly sparse. 6/10/04.</li> </ul>	<ul style="list-style-type: none"> <li>- Continue to be proactive in silt fence repair and maintenance.</li> <li>- Continue to monitor growth of vegetation and if needed, additional seed should be added 6/10/04.</li> </ul>

THE HYDROSEEDDED SLOPE IS EXPERIENCING GRASS COVER GROWTH BUT IS STILL A LITTLE SPARSE IN SOME AREAS. 6/10/04

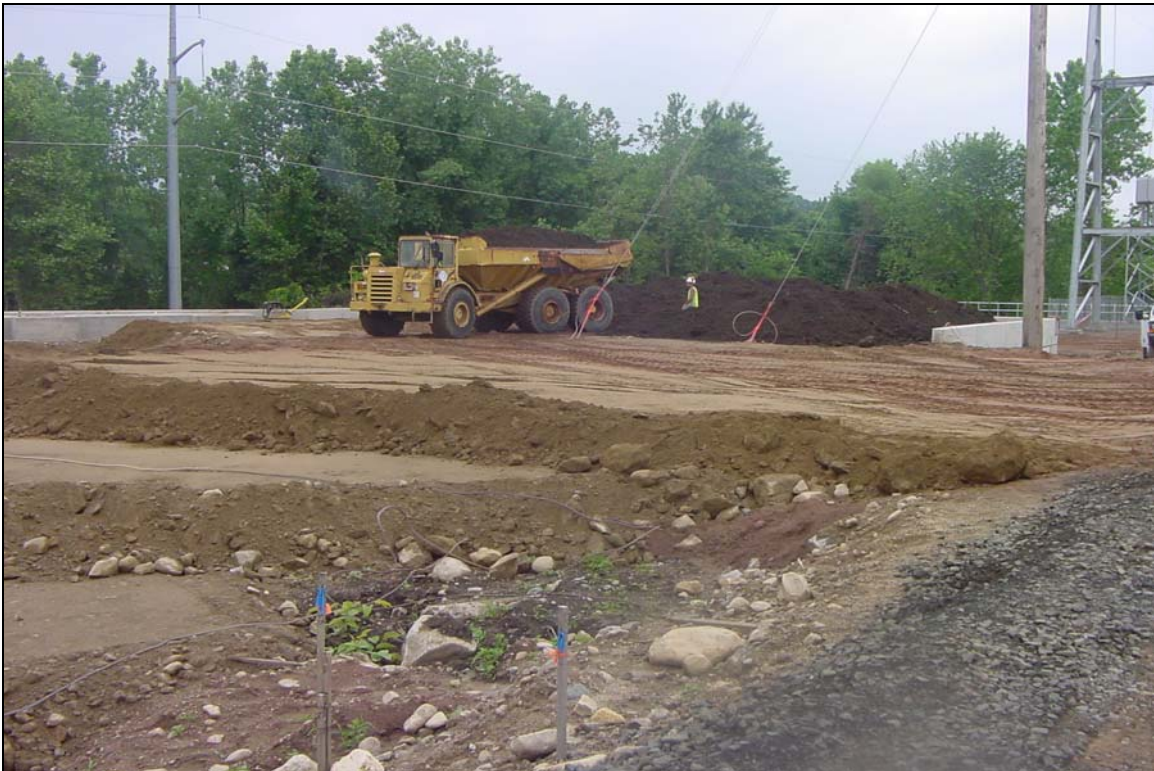
VIEW OF BACKFILL AND GRADING OPERATIONS NEAR WALL #1. 6/10/04

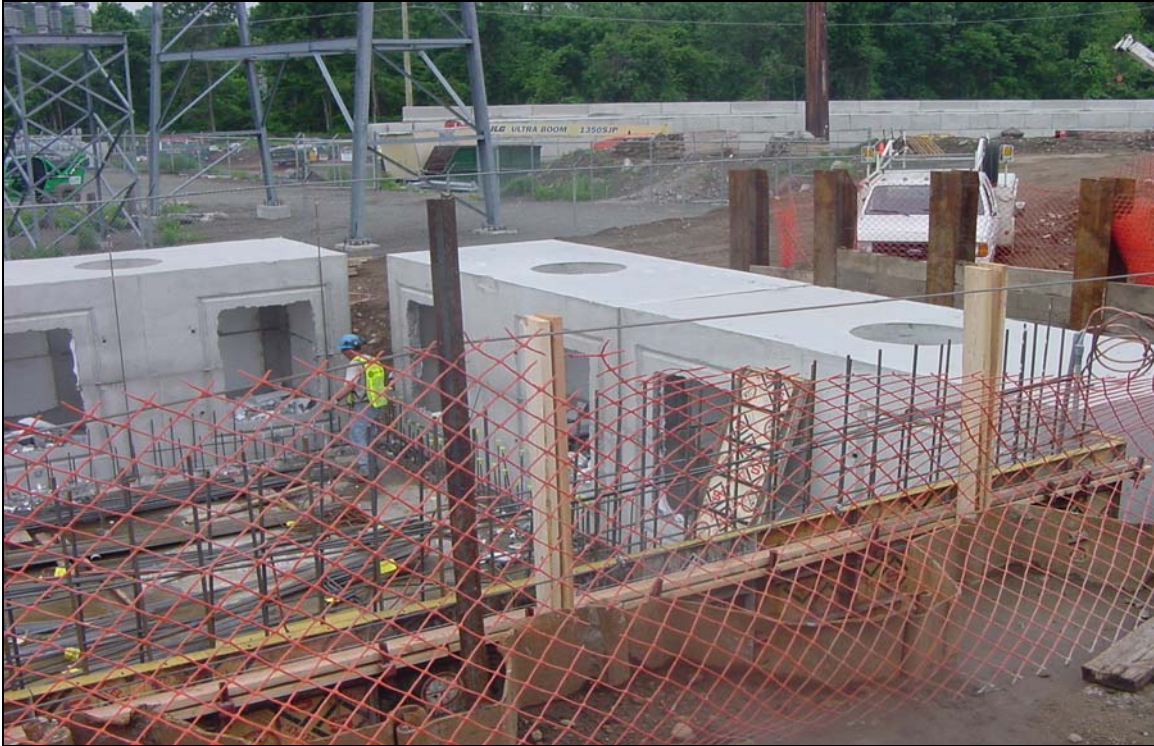
VIEW OF THE PROGRESS AT THE CONTROL BUILDING CONSTRUCTION. MANHOLE BOXES HAVE BEEN PLACED. 6/10/04

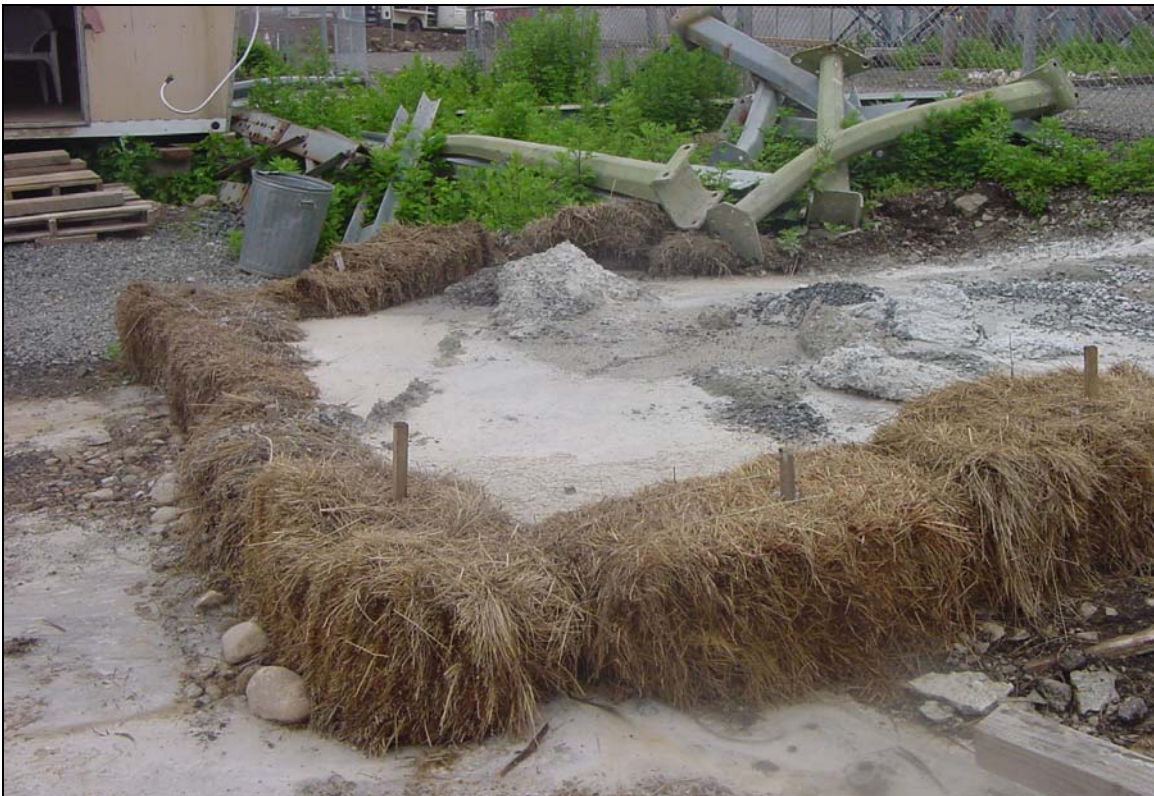
<ul style="list-style-type: none"> <li>- The concrete washout station is full and will be cleaned out. Efforts to use this station have been good. 6/10/04</li> </ul>	<ul style="list-style-type: none"> <li>- The station will be maintained before it is needed again. 6/10/04</li> <li>- The main objective is to keep all washout water from resource areas and storm drains. Continue to utilize and maintain designated stations for concrete.</li> </ul>
	<ul style="list-style-type: none"> <li>- Filling and grading continues in the northern portion of the site near the towers and retaining walls. 6/10/04</li> </ul>	<ul style="list-style-type: none"> <li>- The area is still well contained. 6/10/04</li> </ul>
	<ul style="list-style-type: none"> <li>- The mulched and seeded area near the southern portion of the bike path has strong vegetative growth. 6/10/04</li> </ul>	<ul style="list-style-type: none"> <li>-This area looks good and is on its way to stabilization 6/3-6/10/04</li> </ul>

THE CONCRETE WASHOUT AREA WILL BE CLEANED PRIOR TO ITS NEXT NEEDED USE. 6/10/04
